APPLICATION EXAMPLE OF ROVING WALL METHOD

Slope protection and greening works on a very steep slope

Project Profile

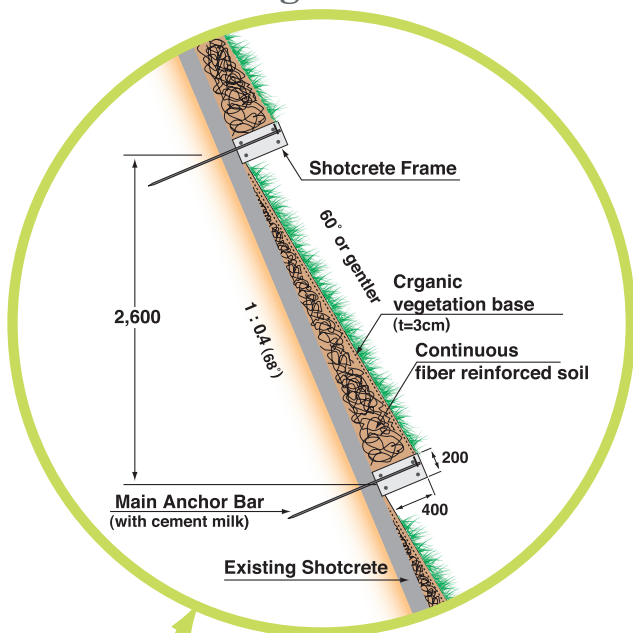
Design Detail

Project Name	Slope Greening Works on Oita road No.10	
Owner	Oita office, Ministry of Land, Infrastructure, and Transport	
Location	Kubaru, Oita Prefecture, JAPAN	
Period	February 1999 to December 1999	
Amount	Continuous fiber reinforced soil	1,842 m ² (thickness=20 cm)
	Organic vegetation base	1,842 m ² (thickness= 3 cm)
Site Description	The deteriorated original surface of shotcrete with planters was upgraded with a completely new look, i.e., all the surface is covered with vegetation.
